DNA-TR-81-162

CHARGING AND DISCHARGING OF SPACECRAFT THERMAL CONTROL DIELECTRICS

Mission Research Corporation
5434 Ruffin Road
San Diego, California 92123

Technical Report

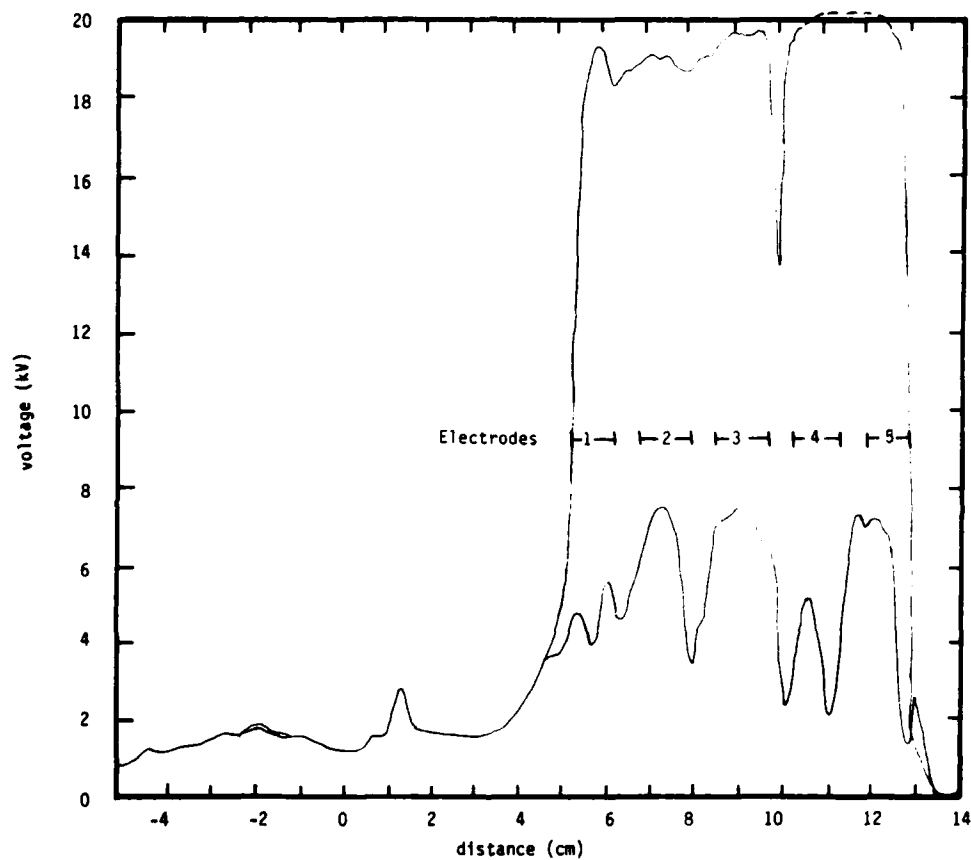
Figure 35. Post-discharge 3:17 potential profile and approximate pre-discharge profile charging with $\approx 1 \text{ nA/cm}^2$ of 23 keV electrons.

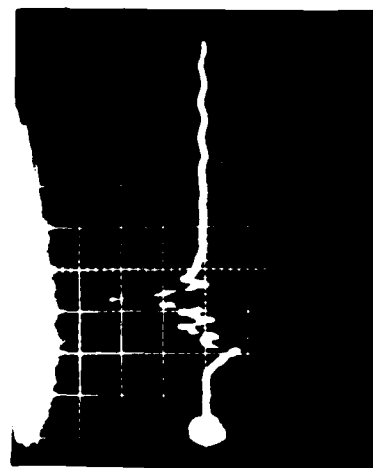
Figure 36. Transient record of discharge 4:35 on 0.013 cm Teflon exposed to 29 kV electrons.

Figure 36 shows transient data record 4/6/82, 4:35. The sample had been charged with 29 kV electrons. This data gives the appearance of a propagation which initiates at, or between, electrodes #1 and 2 propagating toward

electrode 5 at a velocity of $\approx 6 \times 10^7$ cm/s. Unfortunately, we suspect the data recordings on the blow-off collector are not valid (we think it may have been shorted - see note at end of this section). The transient currents on Figure 36 suggest $\approx 16 \mu\text{C}$ were removed from areas above electrodes 1-4 whereas we estimate from $\Delta Q = C\Delta V$ that about $14 \mu\text{C}$ of charge was removed.

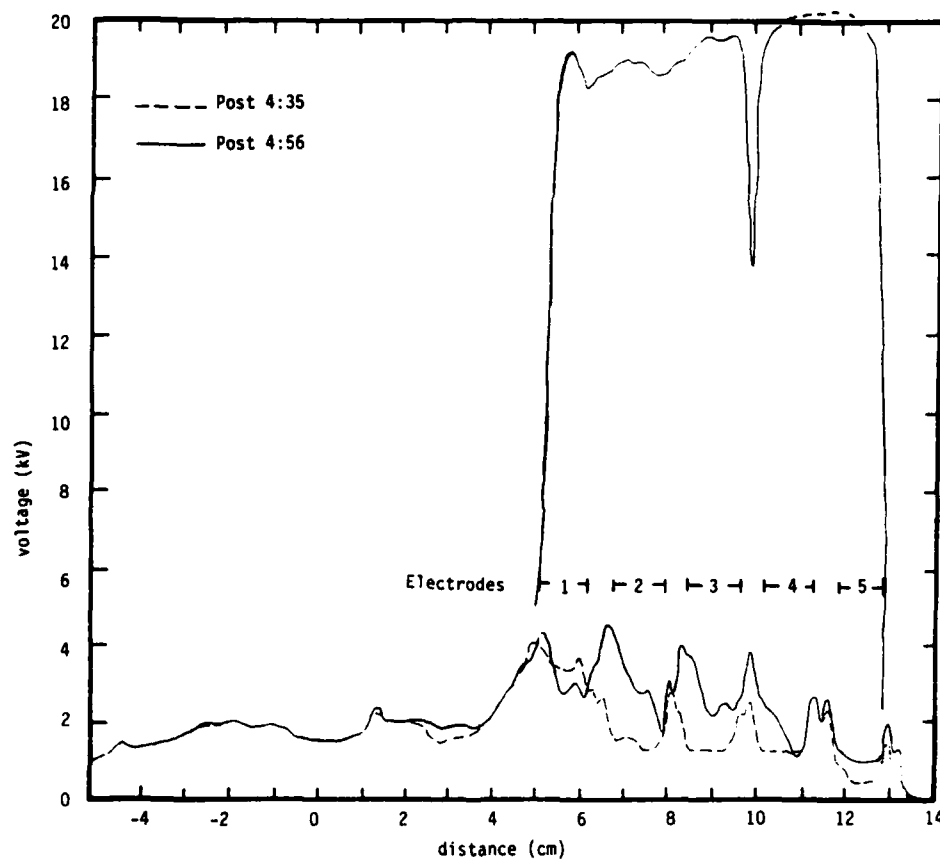
Figure 38. Two post-discharge potential profiles and probable pre-discharge profile. Charging with 1 nA/cm^2 of 29 kV electrons.

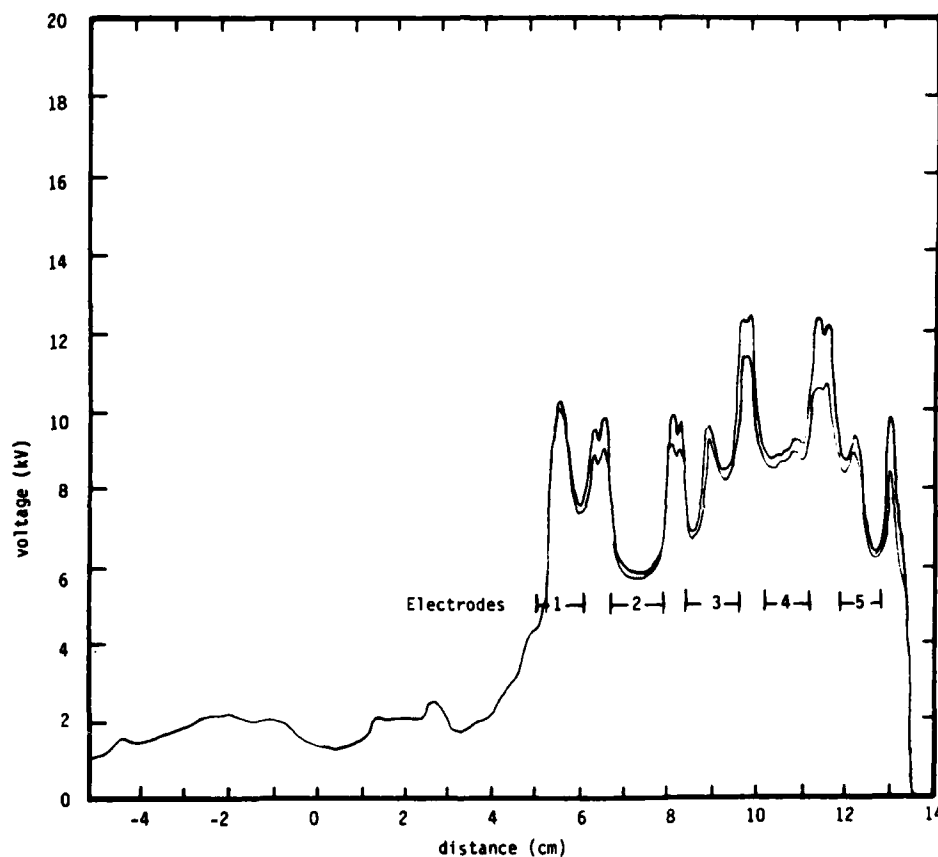
Figure 40. Decay of voltage overnight, after charging with $\approx 1 \text{ nA/cm}^2$ at 30 kV.

Figure 40 shows the result of leaving a sample in a pre-charged condition (peak voltage 11.7 kV) for 14 hours (overnight). These data indicate a dark conductivity of $2.9 \times 10^{-19} \Omega^{-1} \text{cm}^{-1}$ over a period of 5.2×10^4 s.

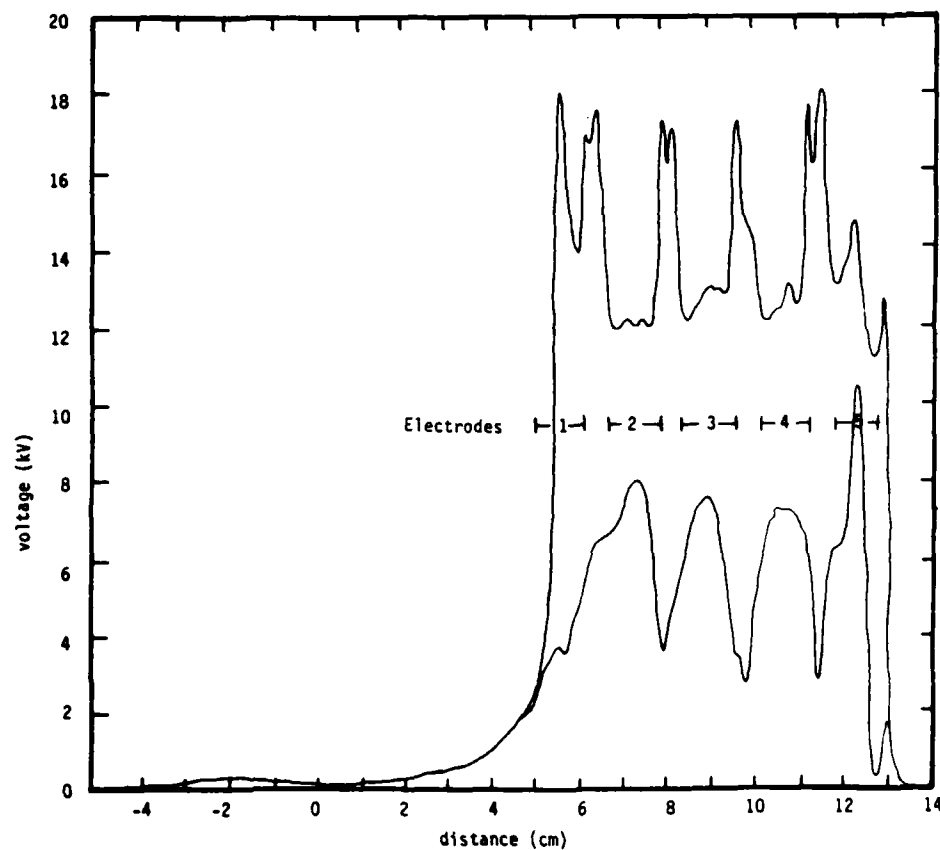
Figure 41. Potential profiles before and after a discharge induced by TREK probe striking the metal at the edge of the sample. Charging with $\approx 0.5 \text{ nA/cm}^2$ of 23 kV electrons.

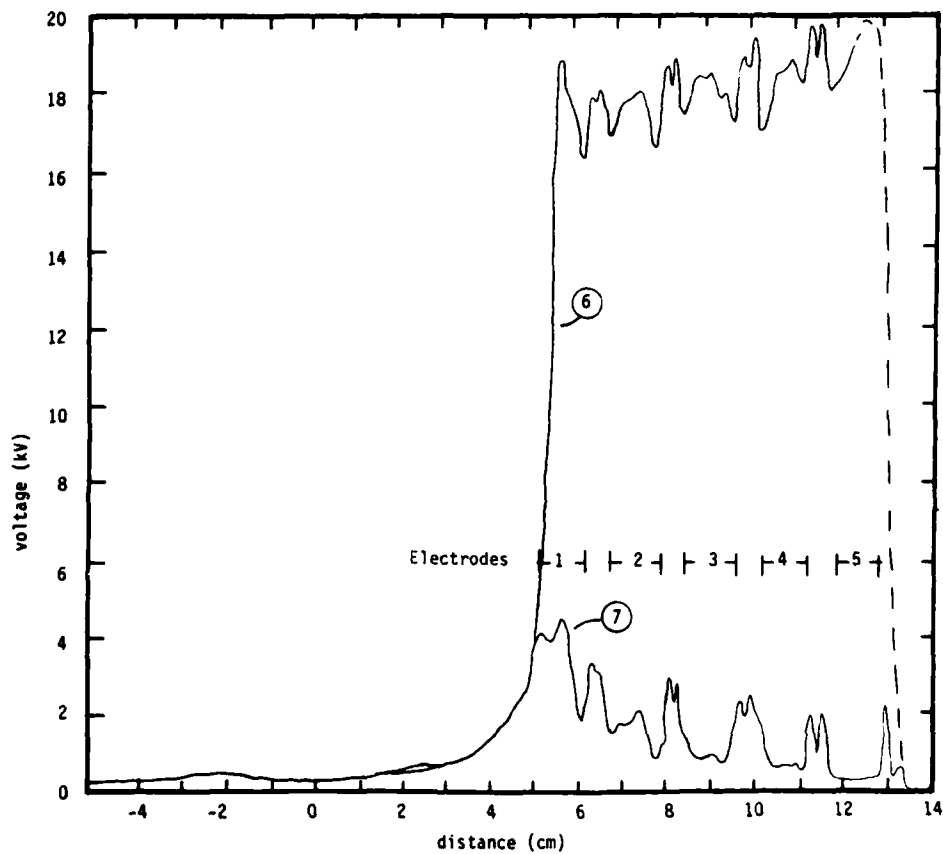
Figure 42. Potential profiles before and after discharge event 6:04. Charging with 0.5 nA/cm^2 of 23 kV electrons for ~20 minutes before sweep ⑥. Two minutes of 26 kV electrons before event 6:04 and sweep ⑦.

Trace 6, the beam was on at 26 kV for 2 minutes at $\approx 0.5 \text{ nA/cm}^2$, which caused a spontaneous discharge. Figure 43 shows the transient data record from that event showing the discharge propagating from electrode 5 (the metal dielectric edge) toward electrode 1 (open dielectric) at a rate of $\approx 4 \times 10^7 \text{ cm/s}$.

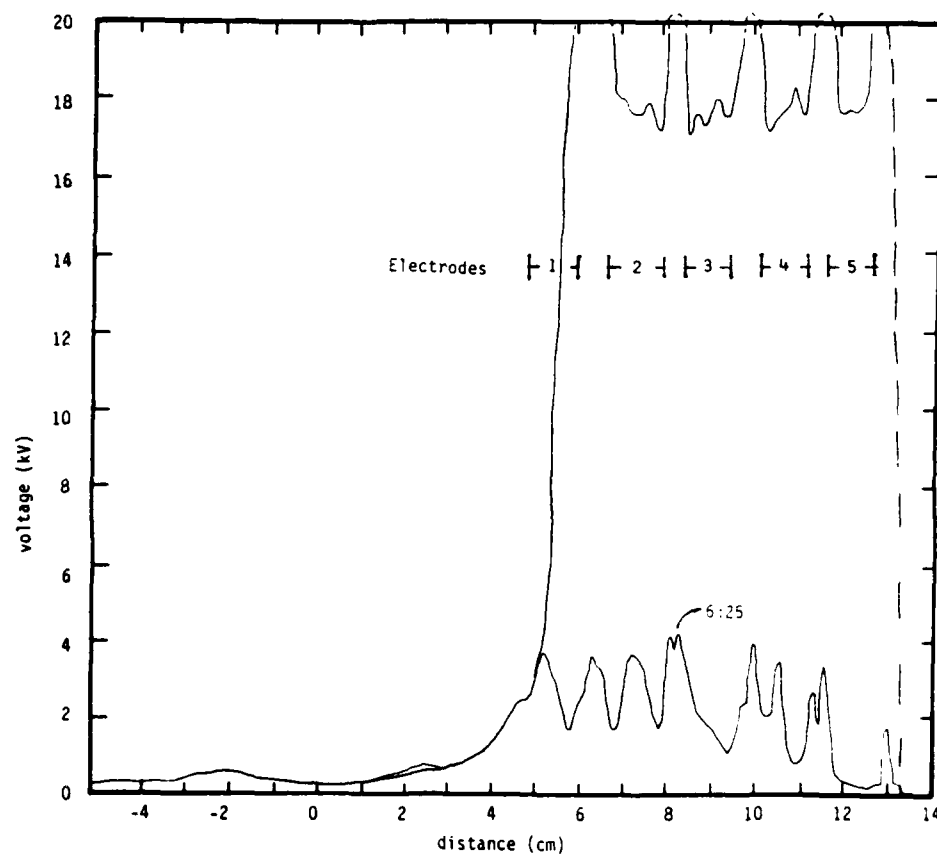
Figure 44. Potential profiles shortly before and just after discharge event 6:25. Charging with 0.5 nA/cm^2 of 26 kV electrons.

Figure 44 shows the potential profile of Teflon charged with 26 kV electrons for 12 minutes, resulting in a potential of nearly 20 kV. Two more minutes of charging caused spontaneous discharge event 6:25.

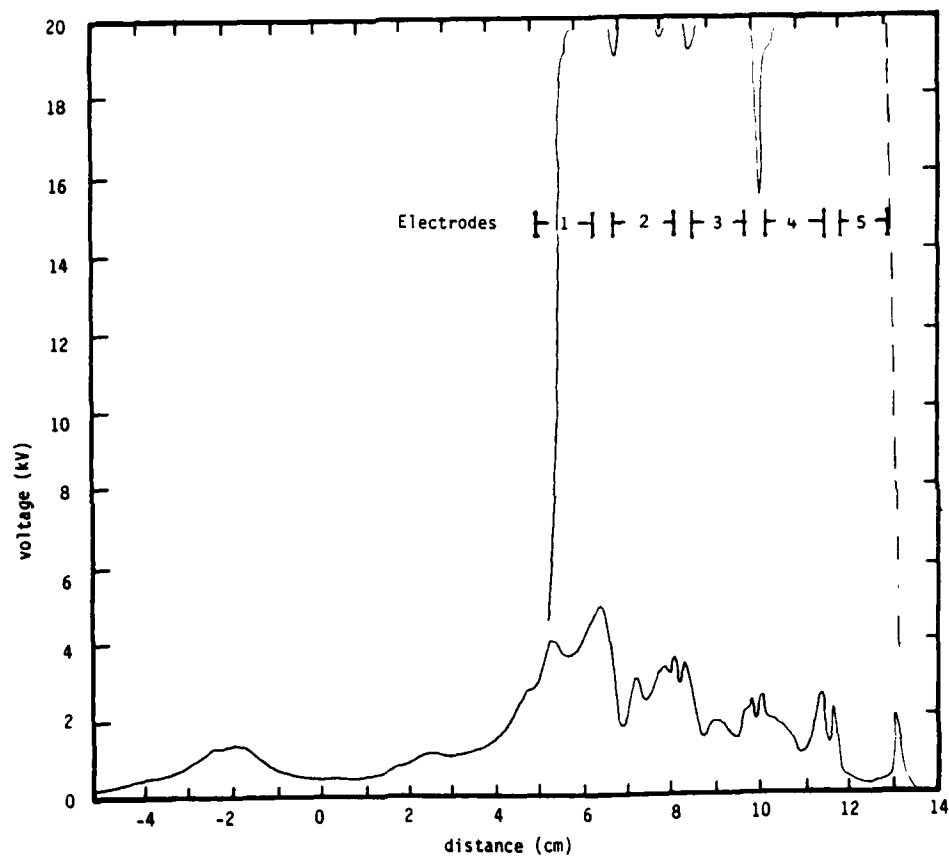
Figure 46. Post-discharge profile and estimated pre-discharge profile for event 10:50. Charging at 26 kV with 1 nA/cm².

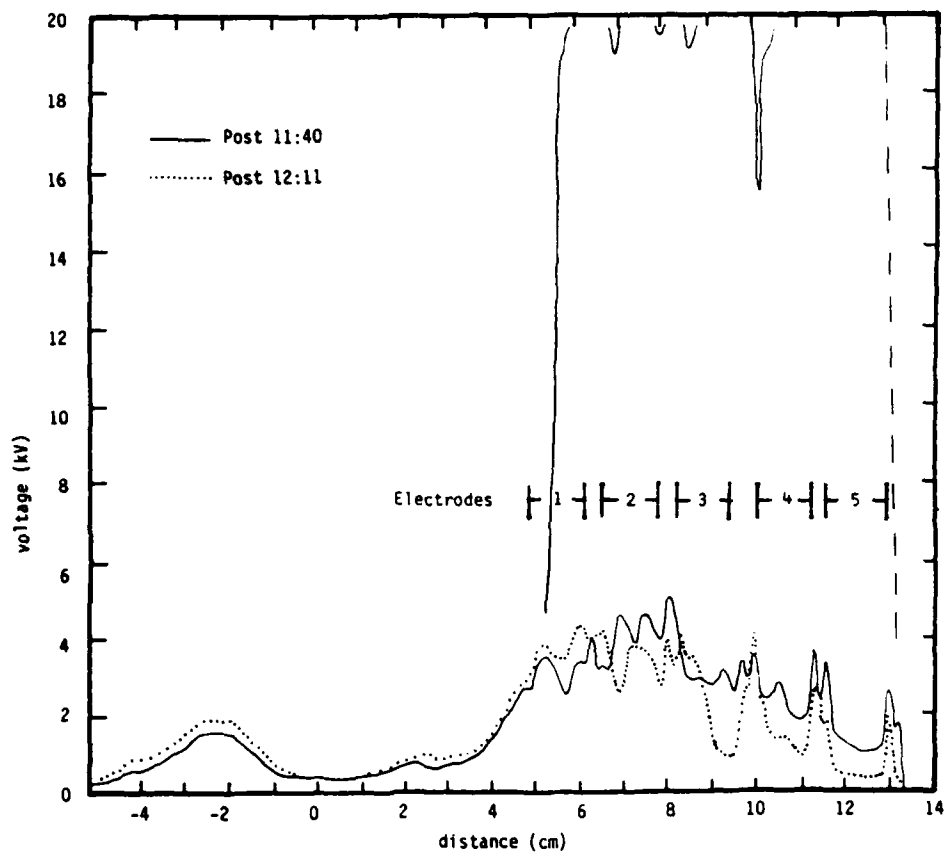
Figure 48. Post-discharge profiles and estimated pre-discharge profile. Charging with 1 nA/cm^2 of 26 keV electrons.

Figure 48 shows the pre- and post-discharge potential profiles for events which occurred at 11:40 and 12:11 on 4/9/82. At 11:40, the sample had been charged at $\approx 1 \text{ nA/cm}^2$ for 6 minutes with 26 kV electrons; at 12:11, it had been charged for ≈ 9 minutes. The transient records that accompany these are shown in Figures 49 and 50. Figure 49 shows a propagation from the dielectric-metal boundary toward the center of the sample at a rate of about $3.4 \times 10^7 \text{ cm/s}$. Figure 50 shows a similar propagation. It should be noted that event 12:11 occurred 45 seconds after the impinging electron beam had been turned off.

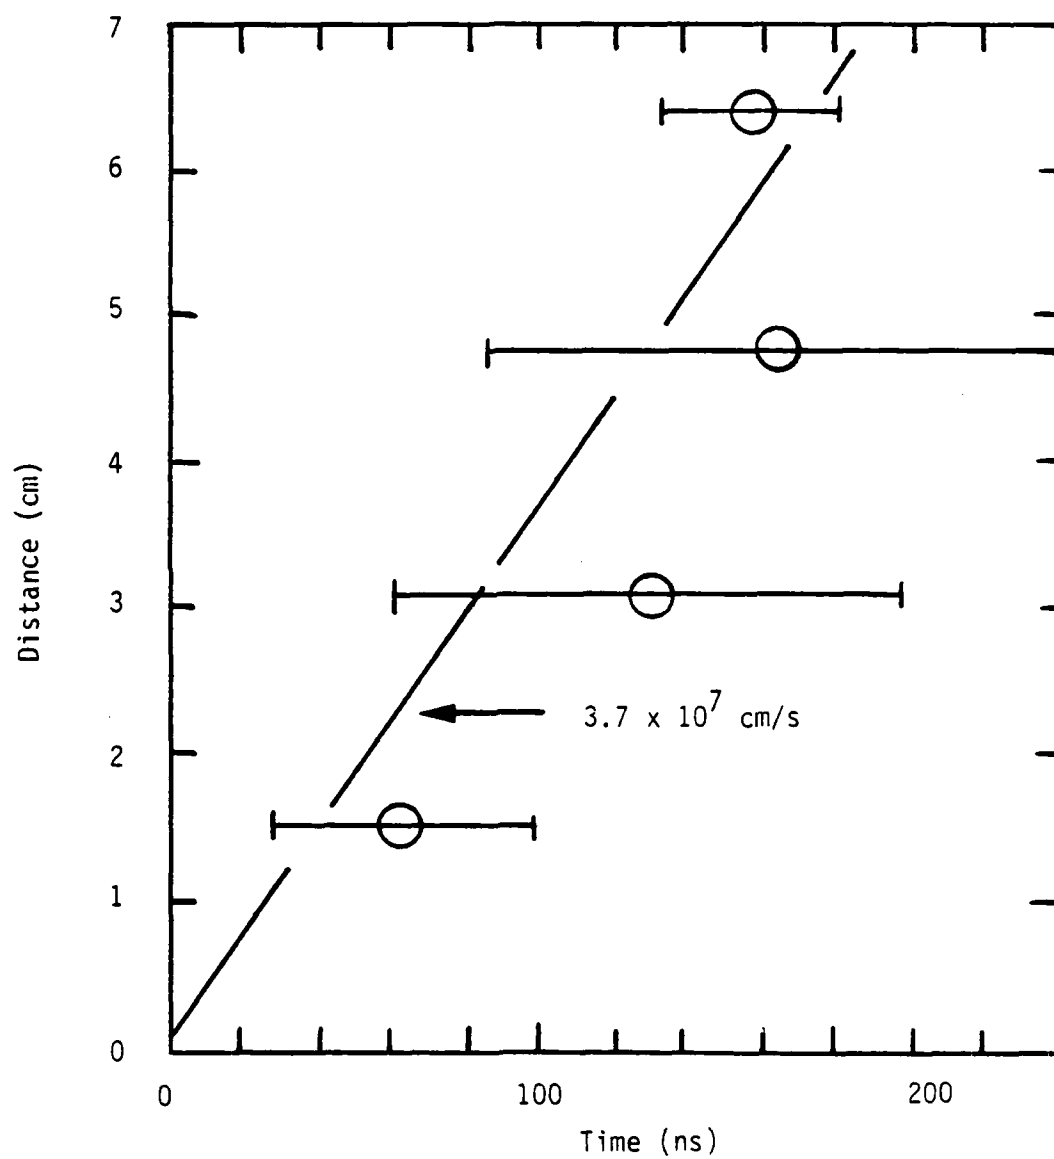
Figure 51. Compilation of the discharge propagation data for 0.013 cm (0.005") Teflon. Discharge distance versus time after initiation.

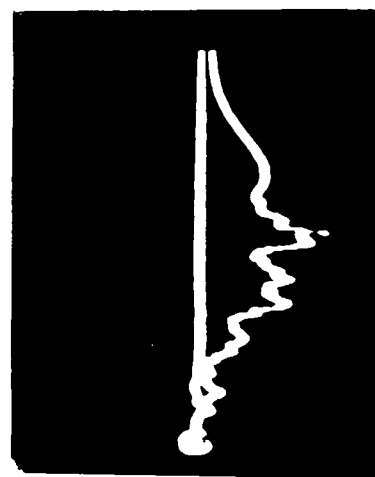
Figure 52. Transient record of discharge 3:33 on 0.0025 cm Mylar exposed to 21 kV electrons.

The first several figures in this section exhibit some of the discharge characteristics observed for precharged Mylar. Figure 52 shows a discharge (4/1/82, 3:33) which initiates at the outer-most ring, or dielectric-metal boundary, and propagates in a more-or-less continuous fashion to the innermost electrode. Notice that substantial blow-off is observed which corresponds to collection of $\approx 6.4 \mu\text{C}$ of charge. While the discharge propagation velocity is somewhat discontinuous, it is $\approx 1 \times 10^7 \text{ cm/s}$ for this record.

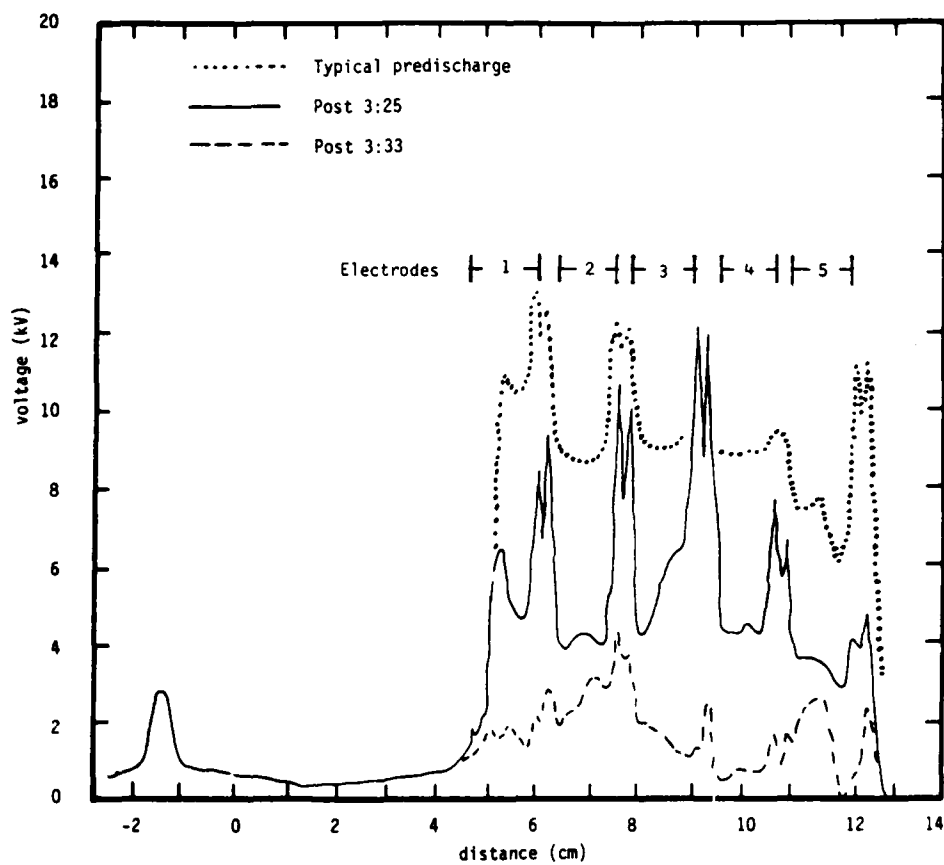
Figure 54. Estimated pre- and actual post-discharge potential profiles. Charging with 2 nA/cm^2 of 21 keV electrons.

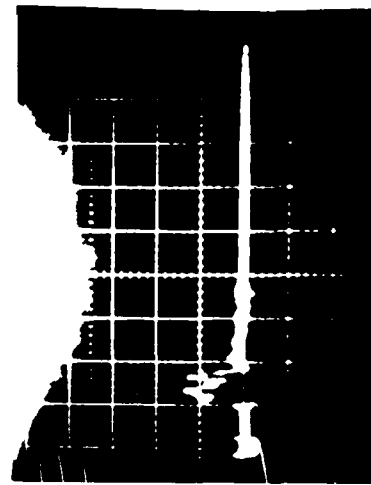
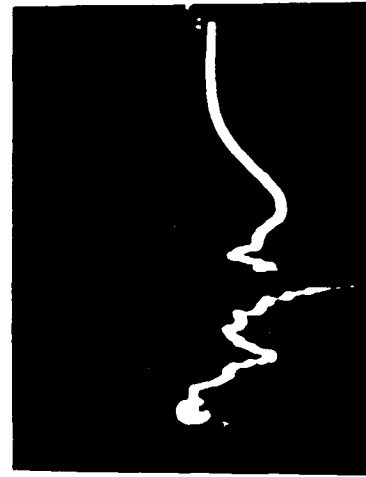
Figure 56. Transient record of discharge 4:01 on 0.0025 cm Mylar exposed to 21 kV electrons.

Figure 55 also is another record of a very small event which discharged only near the metal dielectric boundary. Figure 56 shows another transient record of a propagating discharge. One might infer a propagation velocity of $\approx 2.5 \times 10^7$ cm/s from this record, based on time of arrival of the discharge pulse. Again notice that the blow-off collector indicates the collection of negative charge. The post-discharge potential profile for these two records is shown in Figure 57. As before the large discharge removed approximately 5 microcoulombs.

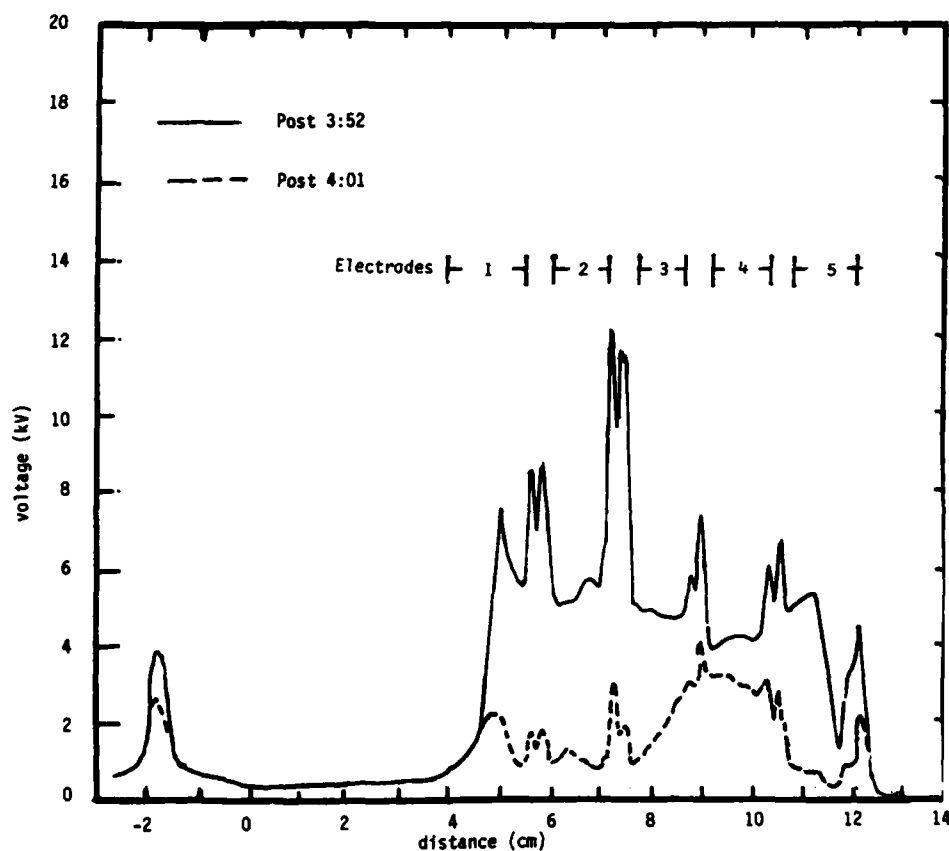
Figure 57. Post discharge profile for events 4/1/82, 3:52 and 4:01. Since 3:52 involved only a small element of the sample, we think 3:52 is a reasonable approximation of pre-discharge profiles. The maximum potential on Mylar was limited by conductivity.

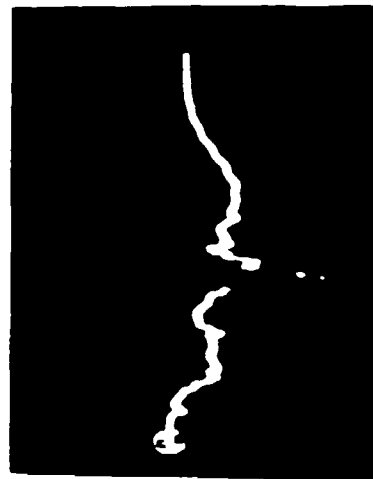
Figure 58. Transient record of discharge 3:14 on 0.0025 cm Mylar exposed to 21 kV electrons.

Figure 58 (4/1/82, 3:14) is the transient record of a discharge which propagates in a peculiar fashion. This discharge initiates over segment #5, near the dielectric-metal boundary and appears next in the adjacent segment, #4, 150 nanoseconds later. It is comparatively insignificant in segment #3 until approximately 720 nanoseconds, which is after it appeared in the innermost segments #2 and #1. Again the blow-off collector is large and negative, indicating the collection of about 4 μC of charge. In other words nearly all the charge which was removed from the dielectric was blown off to the collector. Figure 59 shows the approximate pre-discharge potential profile (obtained by extrapolating from previously measured profiles to the moment of discharge) and (exact) post-discharge potential profile for this event (3:14). There is also evidence from this record also that charge was removed more from the area over segments 1, 2, 4, and 5 than 3.

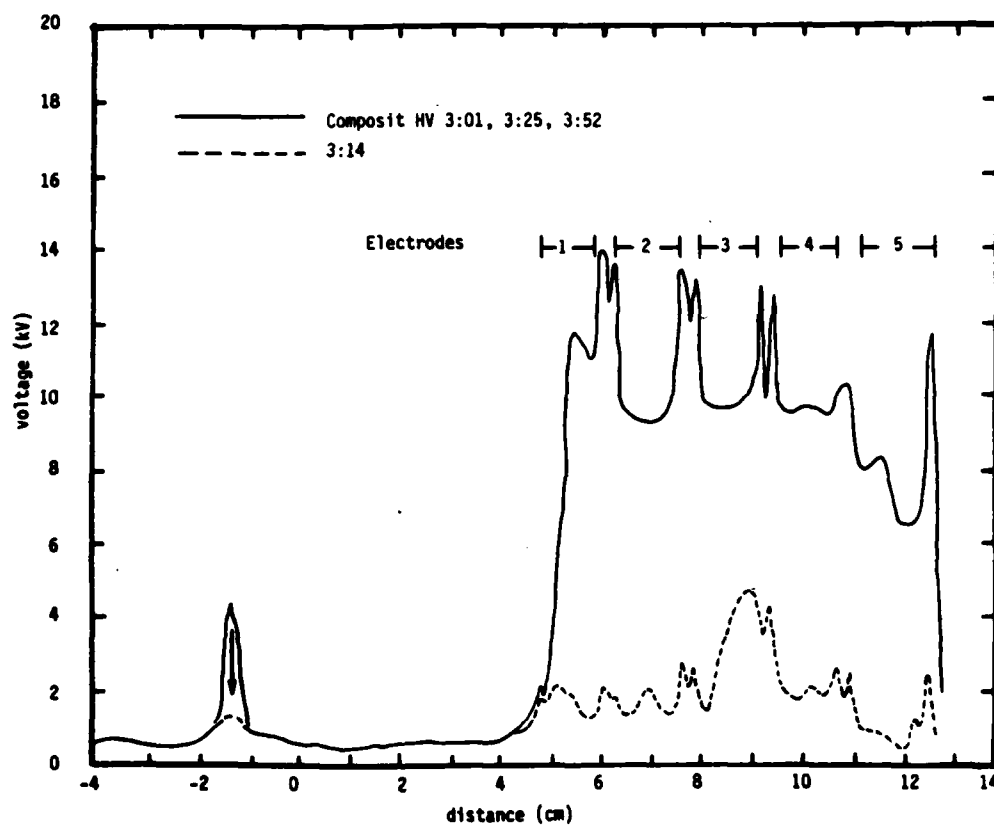
Figure 59. Approximate pre- and actual post-discharge 3:14 potential profiles. Charging with 2 nA/cm^2 of 21 keV electrons.

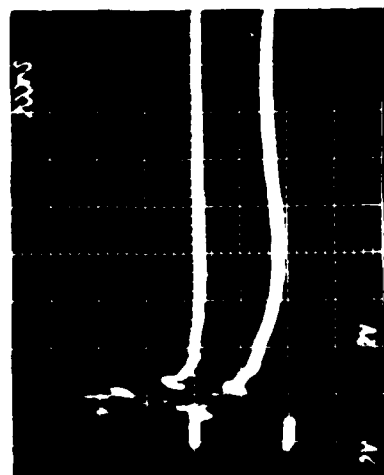
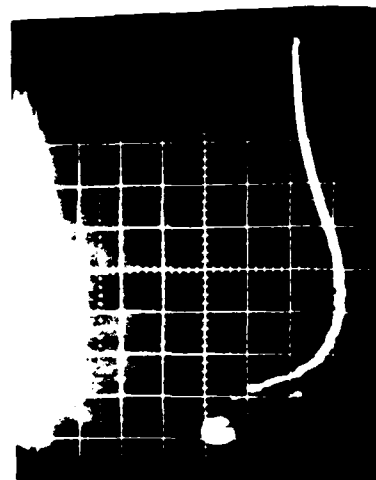
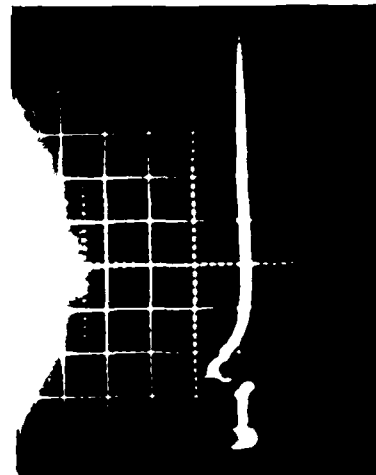
Figure 60. Transient record of discharge 5:41 on 0.0025 cm Kapton exposed to 21 kV electrons. Blow-off collector biased +200 V.

Figures 60 (4/1/82, 5:41) and 61 (4:43) show discharges with another character. In these events the discharge appears nearly simultaneously over all five segmented electrodes, which would correspond to a propagation velocity in excess of 3×10^8 cm/s. These discharges persist, however, for ~200 nanoseconds. Notice that in these cases the blow-off collector had been biased +200 volts and that the large negative blow-off collector signal represents the collection of more than 30 microcoulombs of negative charge. This is somewhat puzzling since that is more than 5 times the amount of charge lost by the sample as determined with the before and after potential profile ($\Delta Q = C\Delta V$) shown in Figure 62. One possible explanation is conduction through, or charge separation of, a neutral plasma in the space above the charged dielectric.

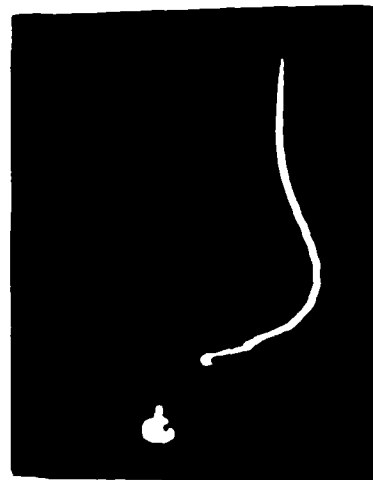
Figure 61. Transient record of discharge 4:43 on 0.0025 cm Kapton exposed to 21 kV electrons. Blow-off collector biased +200 V.

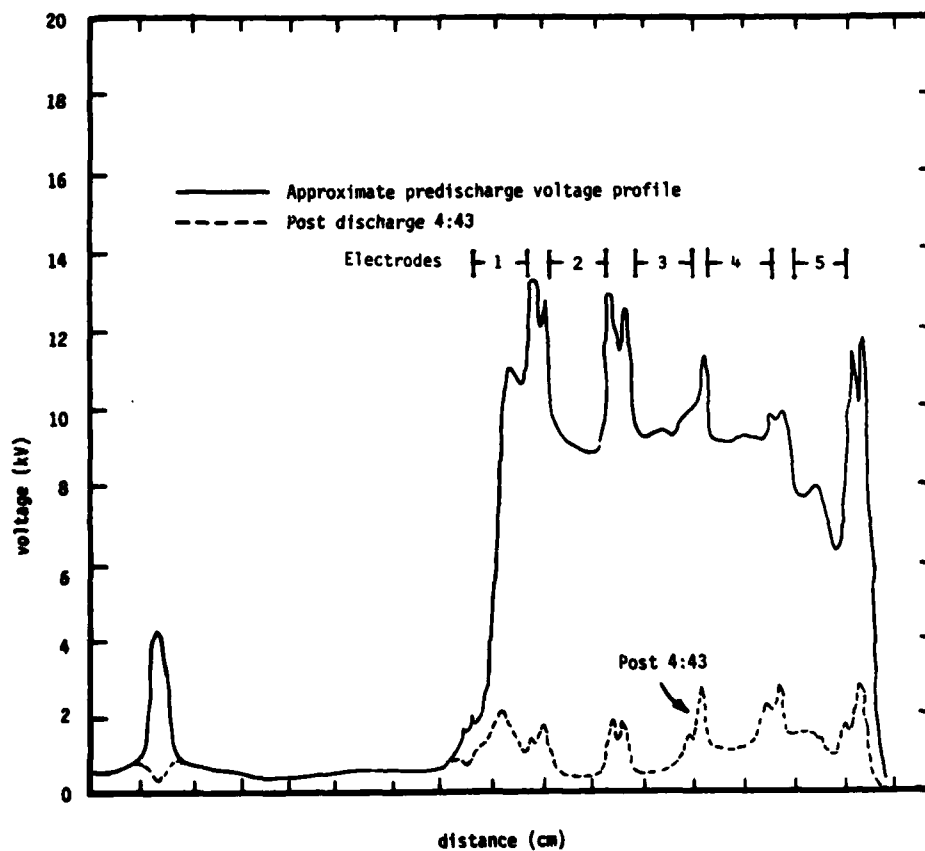
Figure 62. Approximate pre- and actual post-discharge 4:43 potential profiles. Charging with 2 nA/cm^2 of 21 keV electrons.

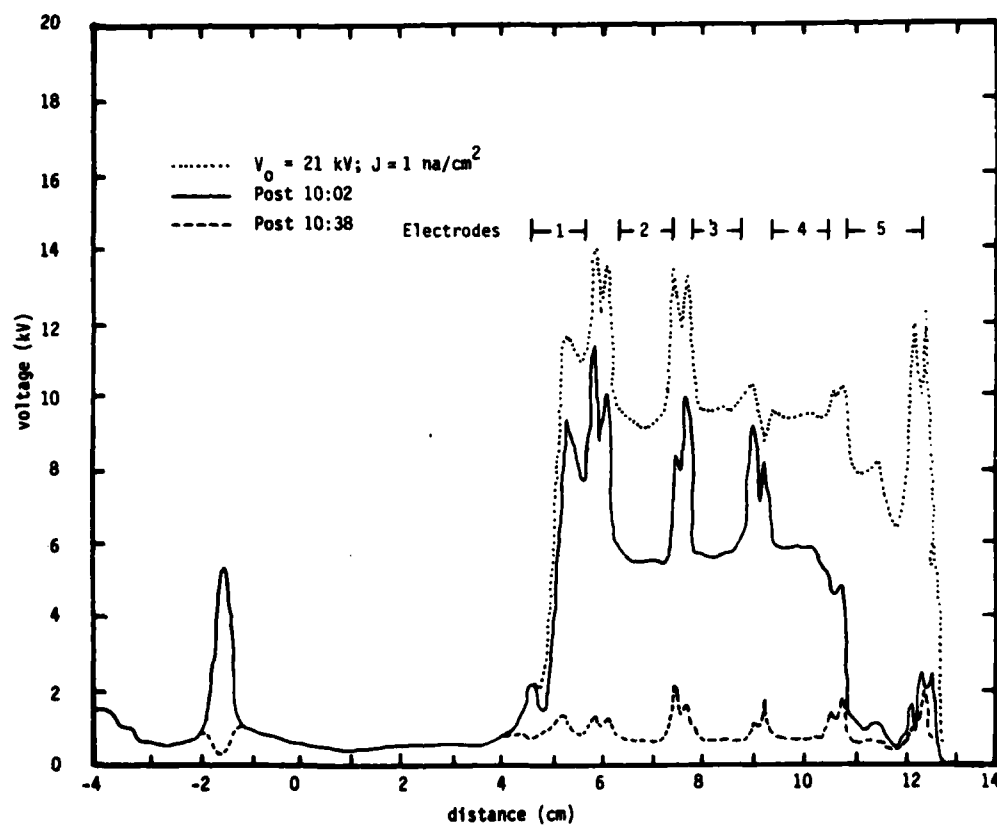
Figure 64. Projected pre- and measured post-discharge (10:02 and 10:38) voltage profiles for 0.0025 cm thick Mylar exposed to $\sim 1 \text{ nA/cm}^2$ of 21 kV electrons.

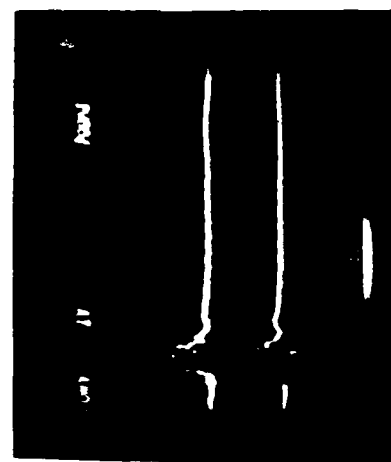
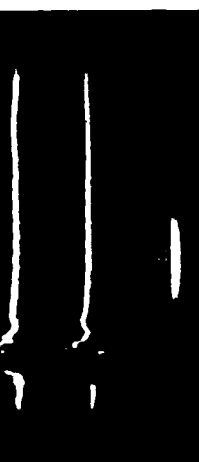
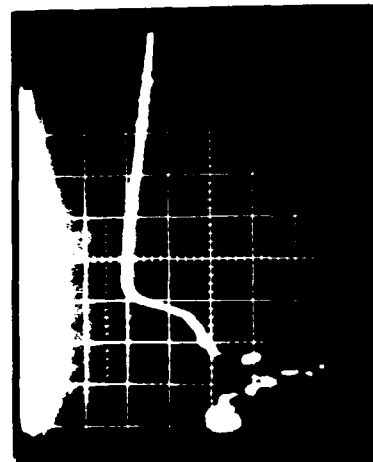
Figure 65. Transient record of discharge 10:38 on 0.0025 cm Mylar exposed to 21 kV electrons. Blow-off collector biased at -200 V.

Figure 65 (10:38) shows another nearly simultaneous discharge over the entire sample surface. In this case the blow-off collector had been biased to -200 volts in an attempt to suppress the blow-off electrons and collect ions (should any be present). There is a prompt negative signal on the blow-off collector, simultaneous with the transient signal on the segmented electrodes followed by a long persistent positive signal which may be due to conduction through a plasma, or the collection of positive ions. The net charge under this signal is probably about 200 μC , which is very large compared to the charge loss ($\sim 30 \mu\text{C}$) inferred from the potential profile before and after (10:38) shown in Figure 63. This would seem to confirm the hypothesis that the discharge generates a neutral plasma which either provides a conducting path between the blow-off collector and ground or separates into positive and negative charges which are collected by the blow-off collector according to its bias. Other authors have asserted a plasma is

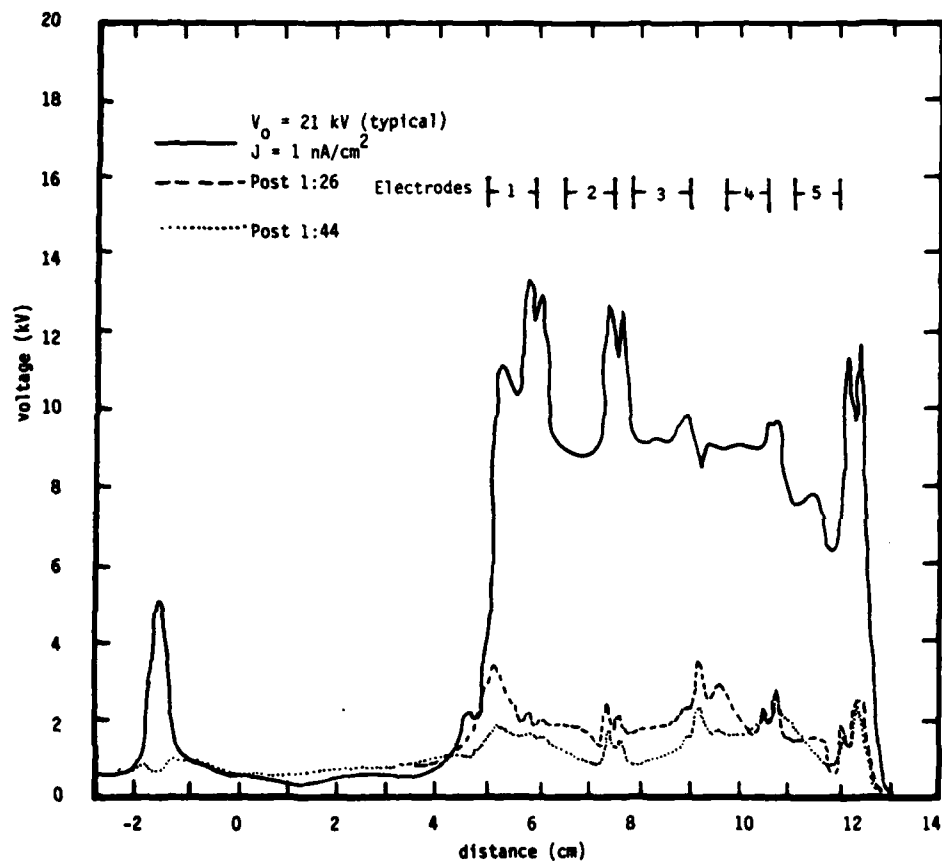
Figure 68. Approximate pre-discharge and post-discharge potential profiles. Charging with 2 nA/cm^2 of 21 keV electrons.

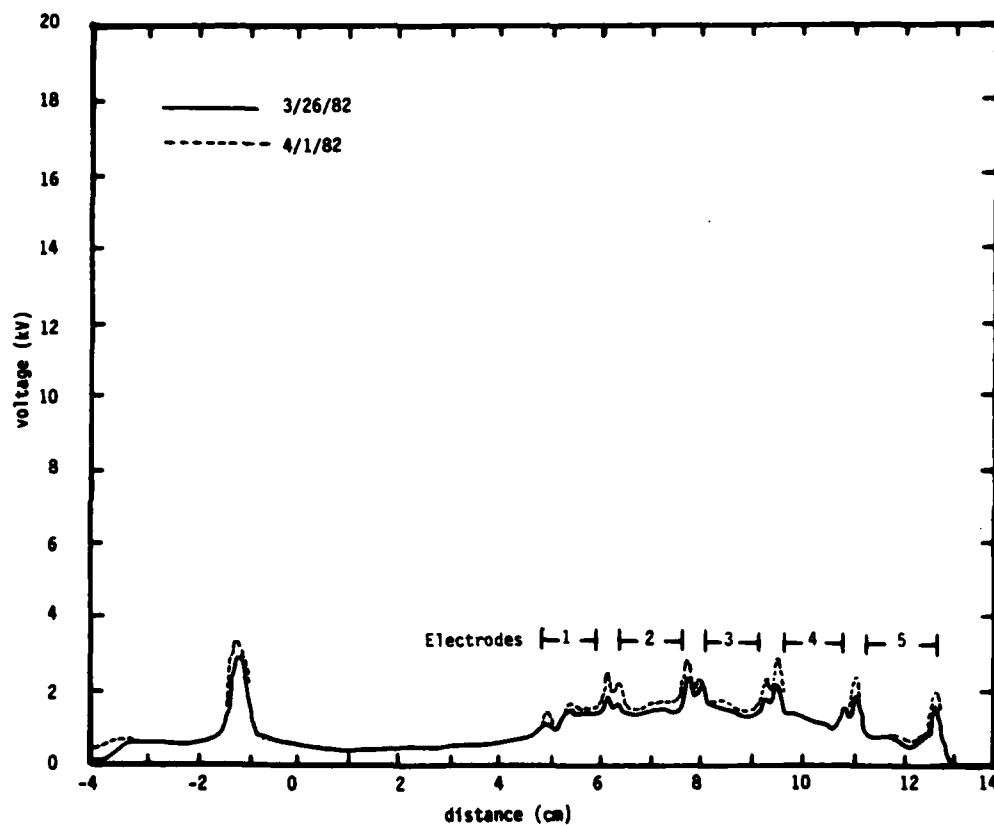
Figure 70. Potential profiles taken six days apart, with sample and scoured between the traces.

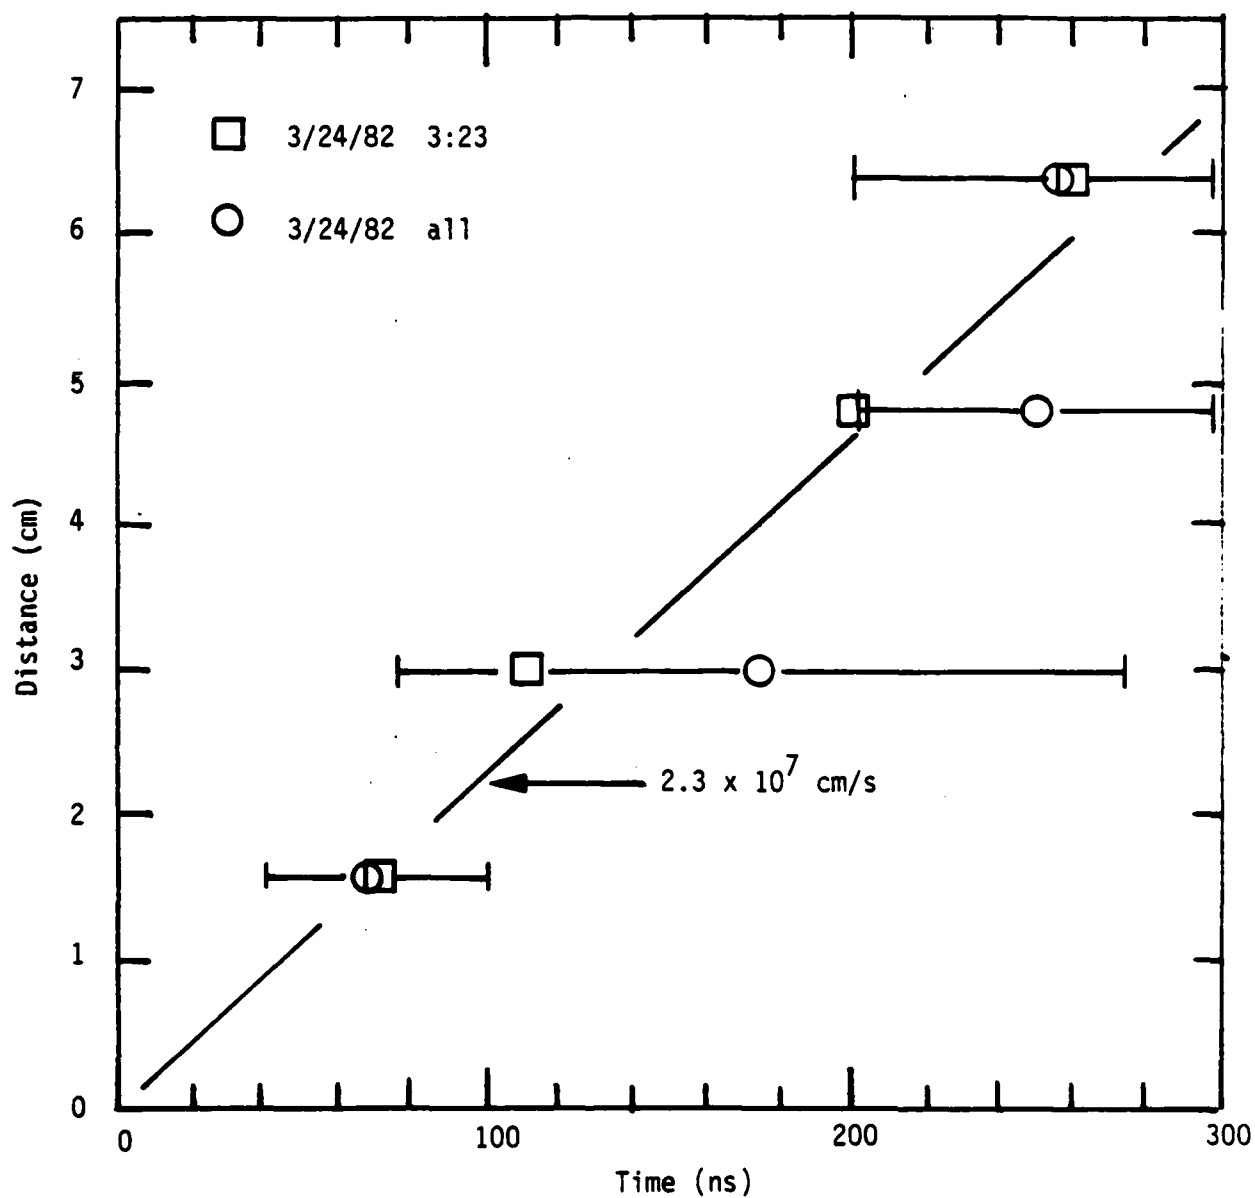
Figure 71. Discharge distances versus time after initiation for five discharge events on 0.0025 cm Mylar on 3/24/82.

Notice that while both sets of records show considerable shot to shot variation in apparent velocity, the average velocities differ by about a factor of two and the data spread just barely overlap. We suspect this is a reflection on anisotropic sample characteristics. Gossland, et al., (Ref. 2) and Wilkenfeld (Ref. 10) have noted a tendency for discharges to run along defects in the dielectric. We suspect the part of the sample irradiated 3/23/82 was oriented with its predominant defects across the segmented sensing electrodes while the part of the sample irradiated on 4/2/82 had defects oriented at an angle with respect to the electrodes (i.e., @ $\sim 60^\circ$).

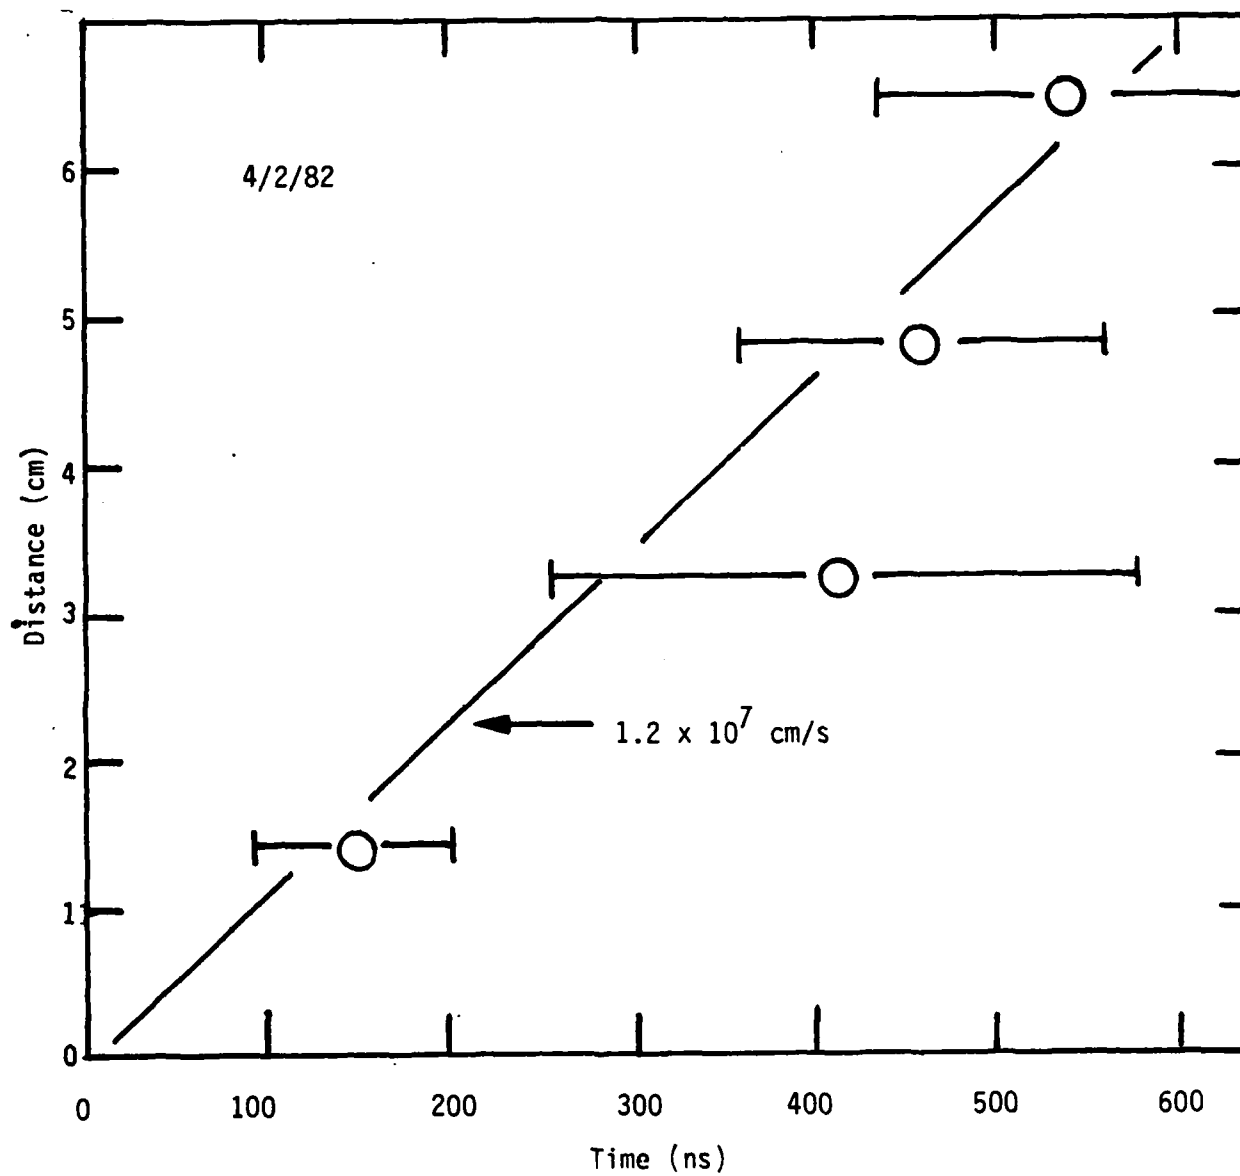
Figure 72. Discharge distance versus time after initiation for five discharge events on 0.0025 cm Mylar on 4/2/82.

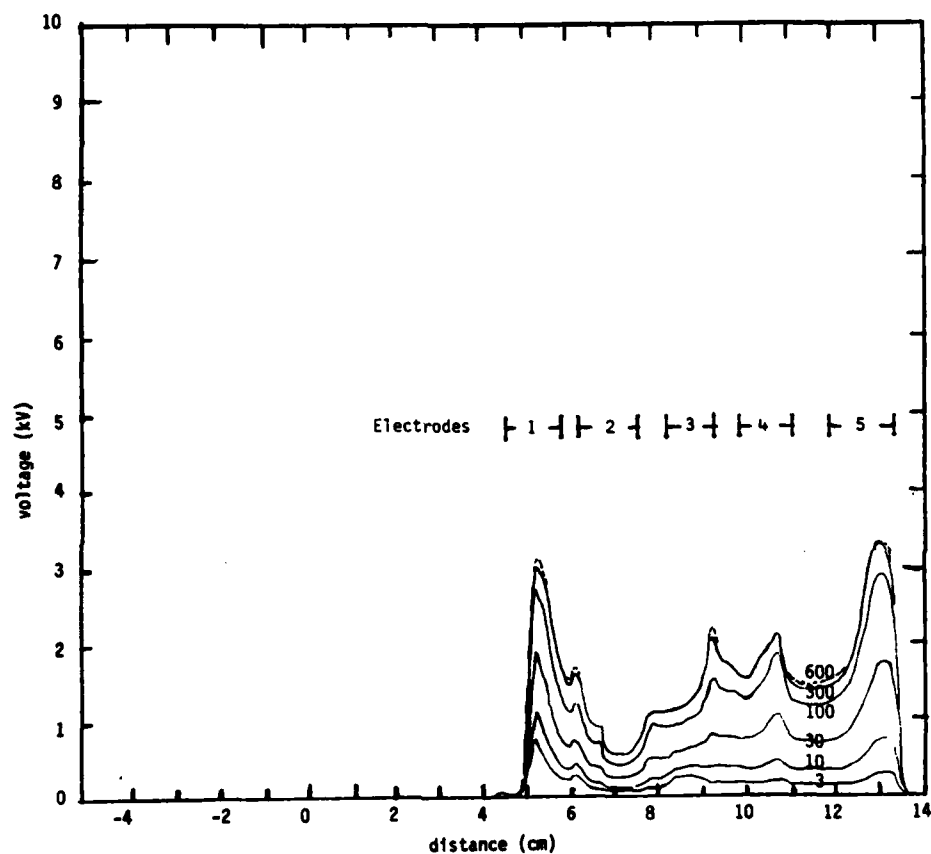
Figure 77. Typical potential profiles from a charging sequence of 0.030 cm solar cell cover glasses, exposed to 0.6 nA/cm² of 6 kV electrons. Exposure time (in seconds) are indicated.

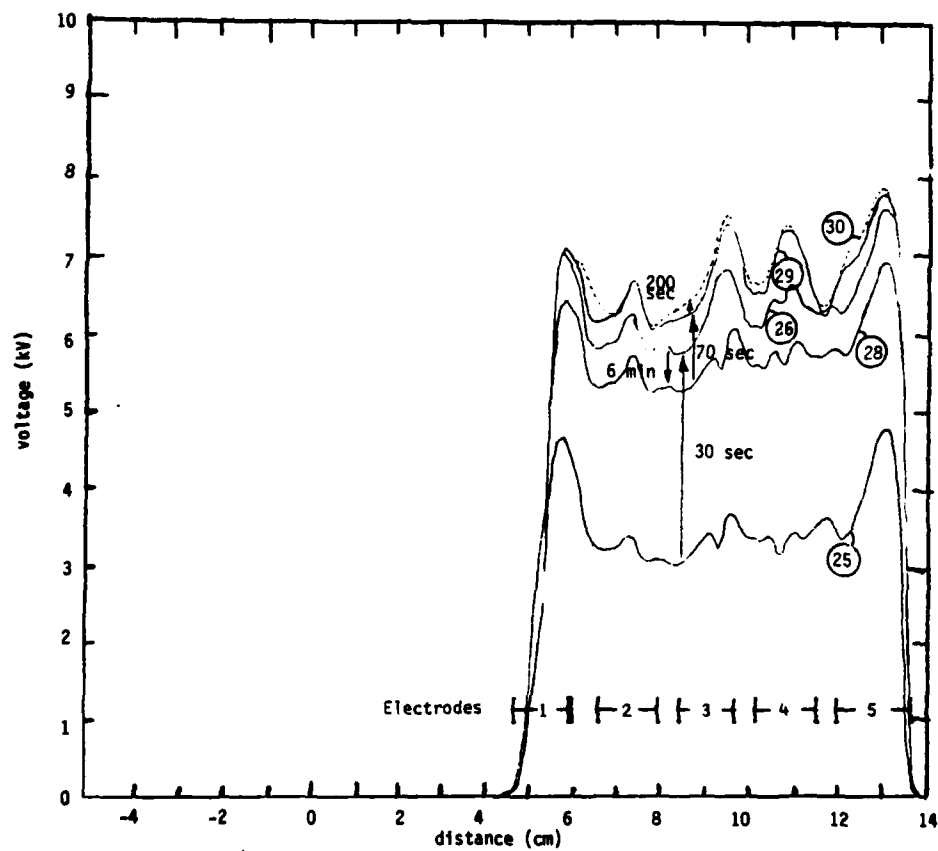
Figure 78. Charging to asymptotic profile on 0.030 cm cover glass with 3 nA/cm^2 of 11 keV electrons. Charging times in seconds. Delays without charging in minutes.
